KOOTENAI DEVELOPMENT IMPOUNDMENT DAM

**OCTOBER 2010 ROUTINE OWNERS INSPECTION AND
PIEZOMETER VIDEO CAMERA INSPECTION**

Prepared by: Kurt Hafferman, P.E.

Inspection Date: October 29th, 2010
Report Date: November 3rd, 2010

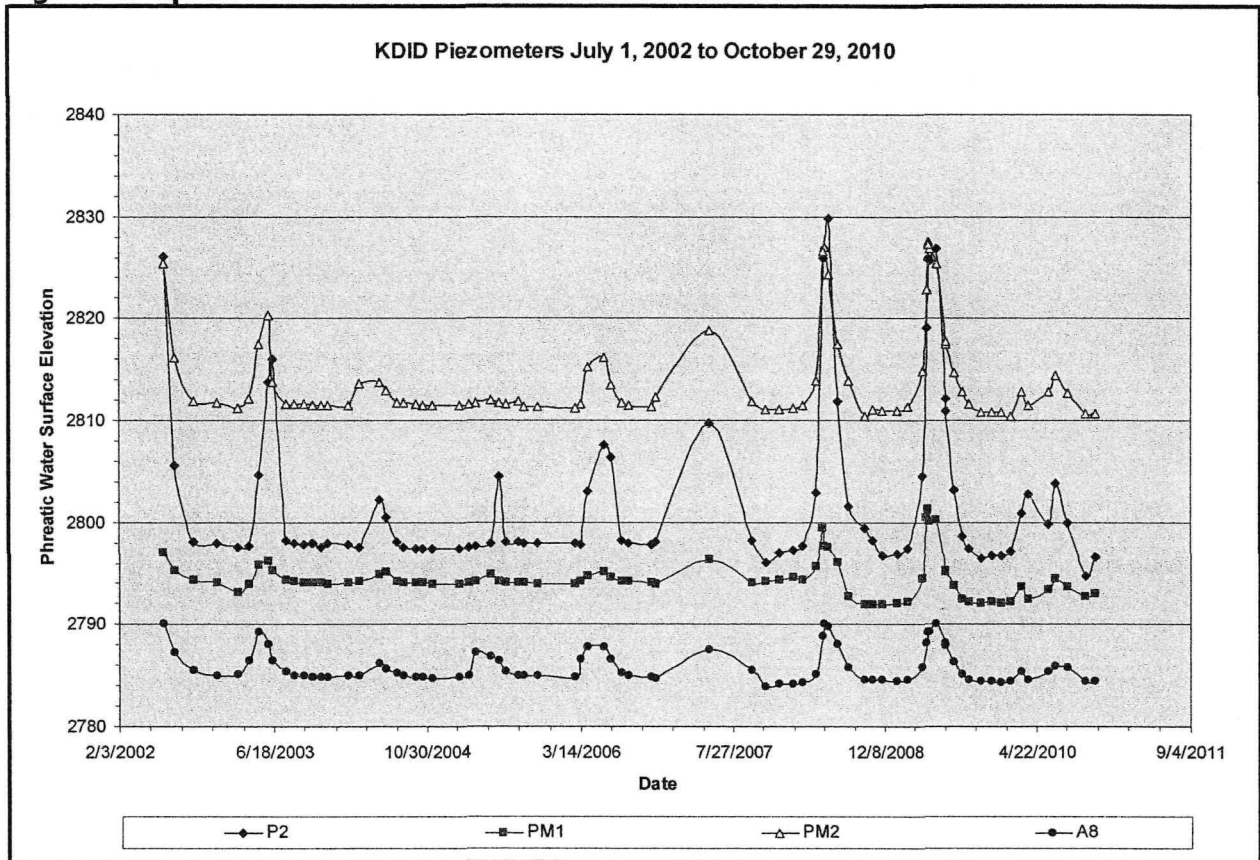
Figure 1: Updated Piezometer Plots

The graph above shows the rise that occurred in late April which was followed by a decline in May and then another rise in late June. As expected we see the continual decline in levels through the end of the water year. This graph shows that highest phreatic water surface in the piezometers only rose to the levels such as those seen in 2003 or 2004.

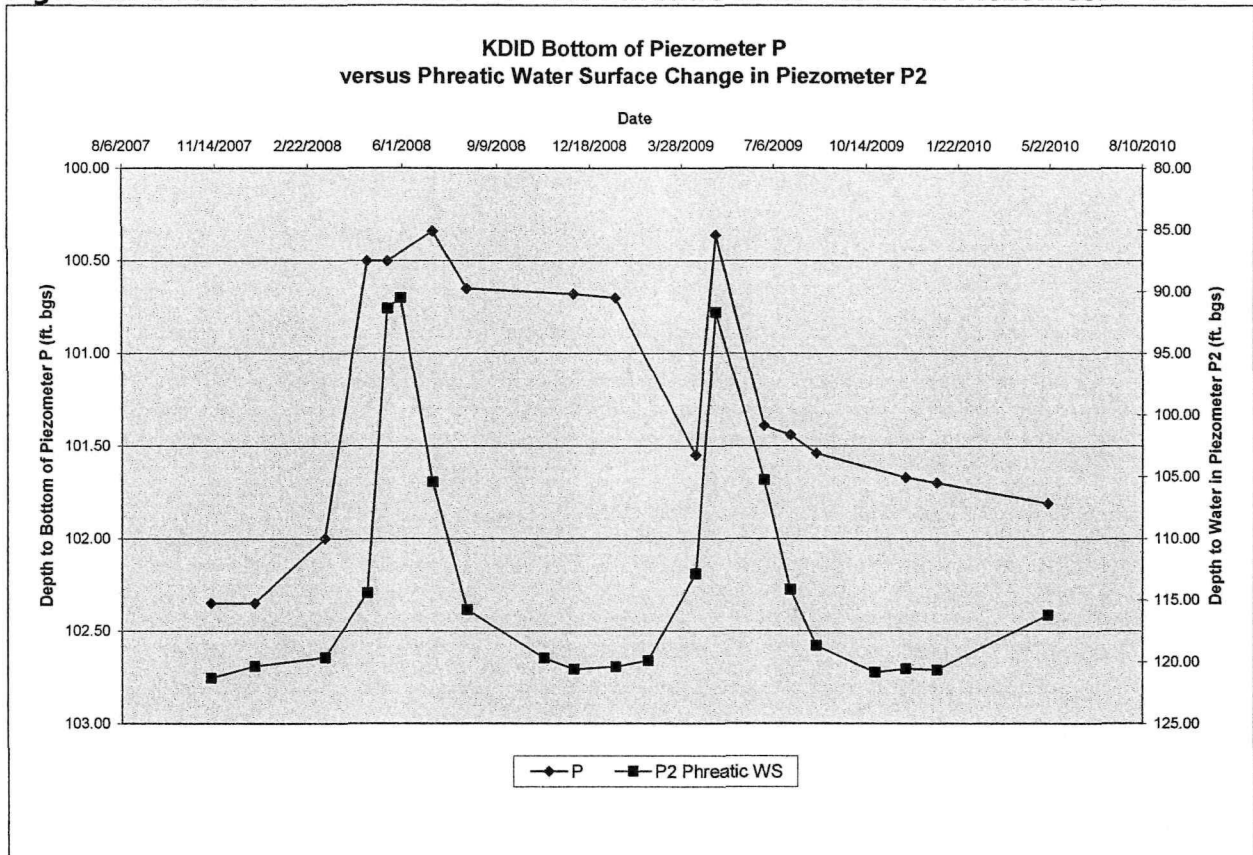
Figure 2: Bottom of Piezometer "P" vs. Phreatic Water Level in Piezometer "P2"

BHI staff verified the bottom of piezometer measurements taken since BHI started readings in August of 2007 and were surprised to learn that the measurement data showed that the bottom of the piezometers have changed and may have varied as much as 2 ft. We then plotted the measured bottom of piezometer P with the phreatic water surface that we measured in piezometer P2, which is the closest wet piezometer to P, and found that there is an annual change in the bottom elevation with somewhat regular fluctuations each year that seem to mimic the rise in phreatic water surface each year. The plot is shown in Figure 2 below.

It should be noted that BHI has never heard of nor experienced an incident where the bottom of a piezometer changed over time. We also contacted the Montana Dam Safety program and they also stated that they had never experienced a change in the bottom of any piezometers, wet or dry. We have always assumed that the piezometer bottoms have never changed.

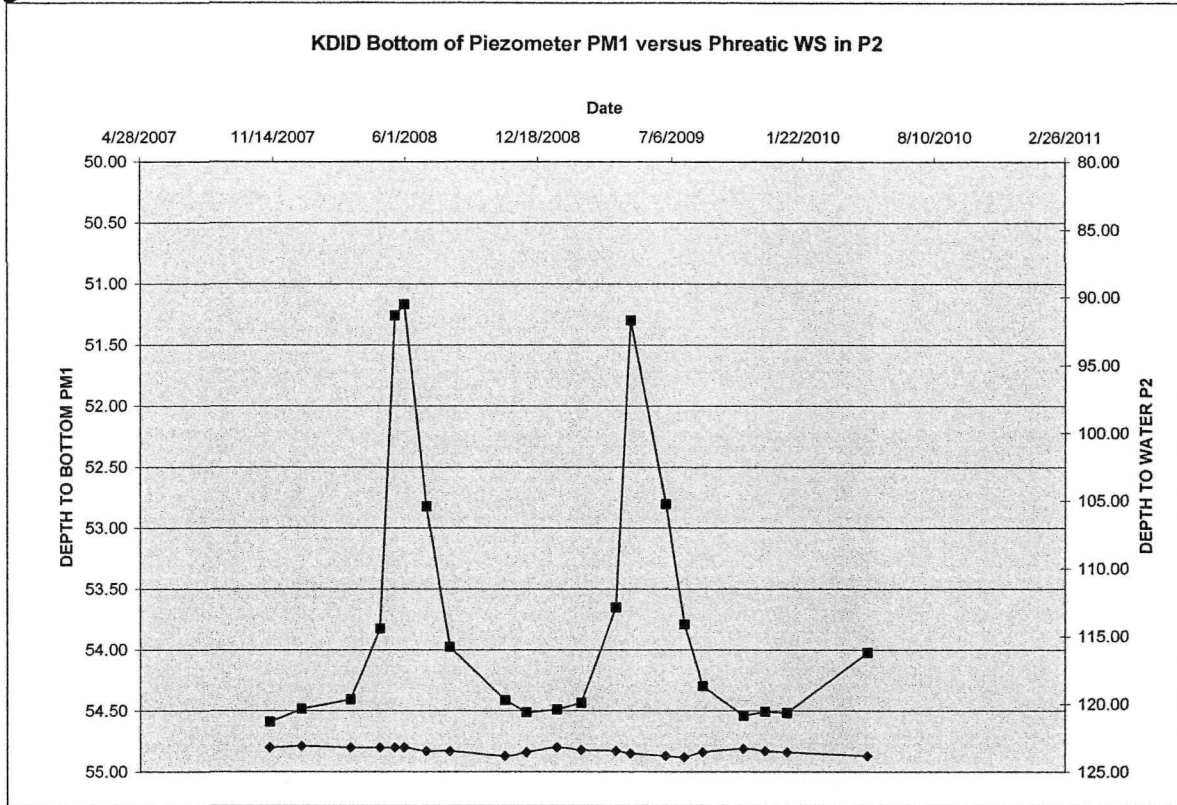
Figure 3: Bottom of Piezometer "PM1 vs. Phreatic Water Level in Piezometer "P2"

As reading the piezometers was typically assigned to Jeff Robertson, formerly of Chapman Construction, we reviewed the records for the bottoms of all piezometers to make observations and possible causes of error. We found that the bottom changed in some piezometers while others were unchanged. It was therefore assumed, because the readings at each individual piezometer were consistent in that they were either changed or unchanged, that operator error should not be considered a factor at this time. The plot of the bottom of piezometer PM1 versus the phreatic water surface change in piezometer P2 shown in Figure 3 below demonstrates that the measured bottom was consistent and that the bottom did not change with a change in phreatic water surface.

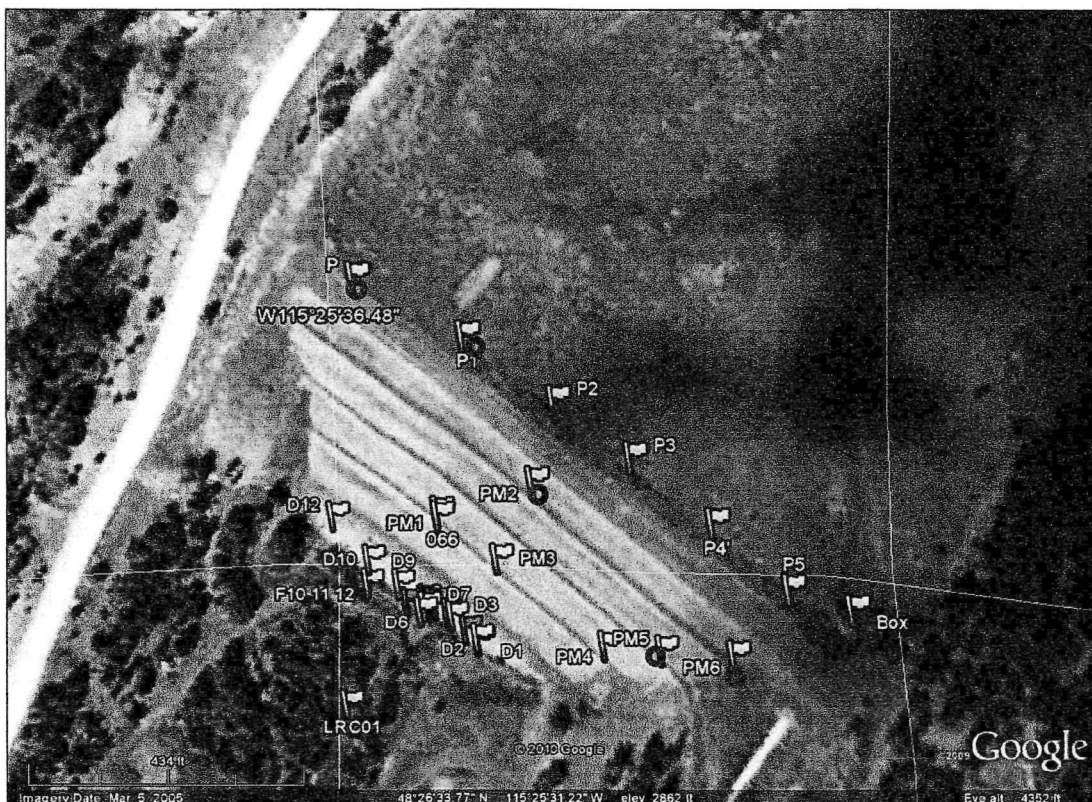
Figure 4: Aerial view of Piezometer locations highlighting changing Piezometers

When we looked at the location of the changed versus unchanged piezometer bottoms we found that there was no consistent pattern where the changes occurred and it was not consistent between the wet piezometers and dry piezometers. The piezometers that have had changes to the bottom elevations are shown in Figure 4 below as the blue circles. As you can see, there is no clear pattern based on location.

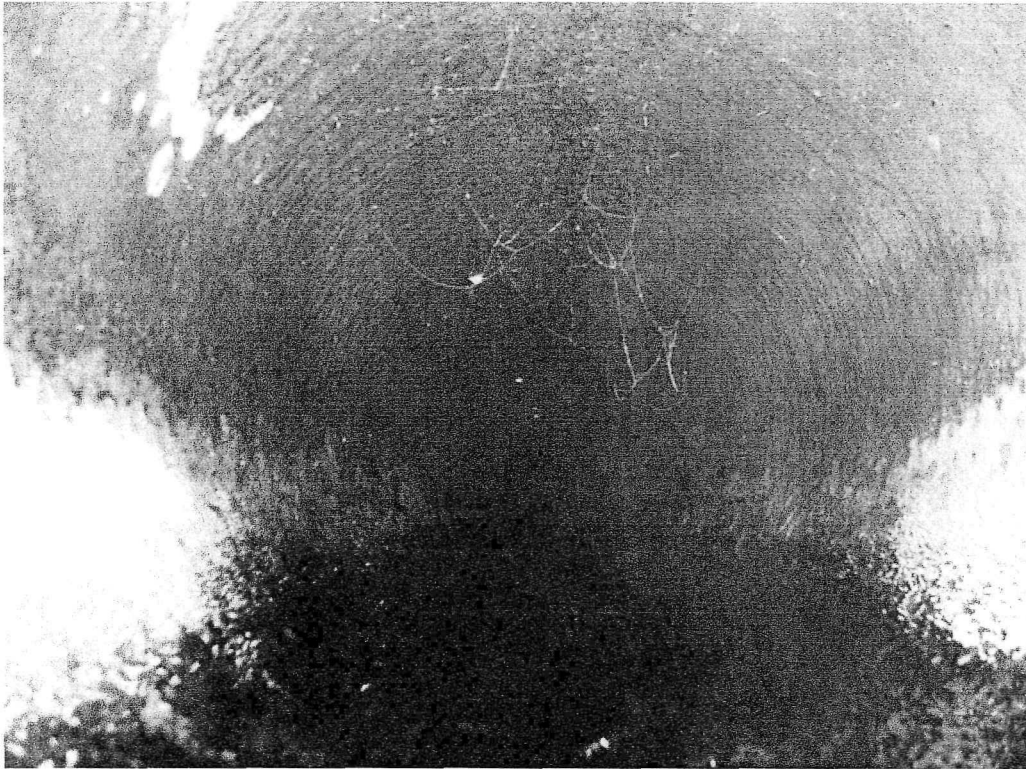
Inside Toe Drain 6

Drain 6, the main drain at the toe, appears to show a decrease in flow over the last month. With drier conditions overall this year, flows have been slower than normal and as the reservoir has drained to low to below normal levels, we are seeing the typical low flows for this time of the year. There are no anomalies to report from this month's inspection.

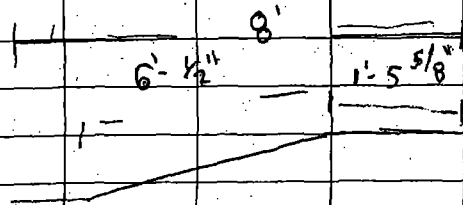
LRC-01 AB MEASUREMENTS

6. As-Built measurements were recorded on the LRC-01 Flume. Repairs made to the flume during the September Routine Owners Inspection have modified the original flume design and flow calculations. As such a new flow chart must be calculated to use with the modified design.
